Management Survey

St. Thomas More Rc School
Oxford Road
Kidlington
Oxfordshire
OX5 1EA

Amity

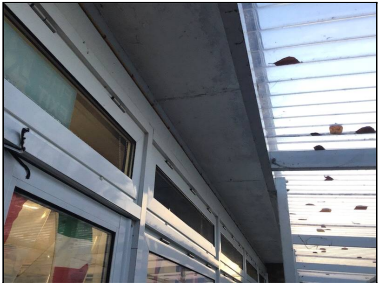
Survey Date:	Lead Surveyor	Survey Type	Floor	Analysis
	20 Dec 2022	Matthew Monro	Management Survey	External	Chrysotile (1)
	Building	Room	Item	Quantity	
	St Thomas More Primary School	External areas E01	Cement board Soffit	7lm	
	Sample No (S,SP,P,As)	Product Type	Surface Treatment	Condition	Accessibility
	AB005146 (S)	Asbestos Cement (1)	Surface Sealed (1)	Low Damage (1)	Usually inaccessible or unlikely to be disturbed
	Material Risk Score				
Recommended action		D - No Attention Required, Label			
Surveyor comments		Cement board used as soffit and upstand around windows of nursery and reception communal area

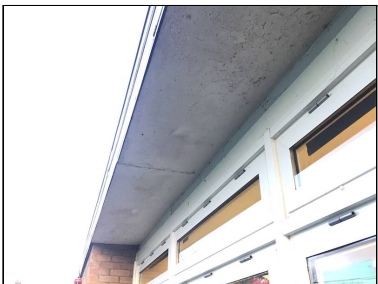
Survey Date:	Lead Surveyor	Survey Type	Floor	Analysis
	20 Dec 2022	Matthew Monro	Management Survey	External	Chrysotile (1)
	Building	Room	Item	Quantity	
	St Thomas More Primary School	External areas E01	Cement board Soffit	5lm	
	Sample No (S,SP,P,As)	Product Type	Surface Treatment	Condition	Accessibility
	As AB005146 (SP)	Asbestos Cement (1)	Surface Sealed (1)	Low Damage (1)	Usually inaccessible or unlikely to be disturbed
	Material Risk Score				
Recommended action		D - No Attention Required, Label			
Surveyor comments		Cement board used as soffit and upstand around windows of reception classroom

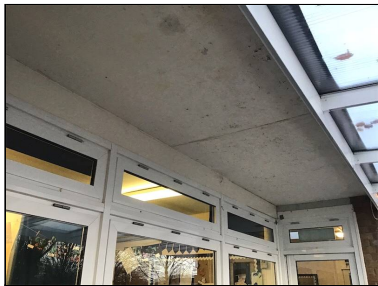
Survey Date:	Lead Surveyor	Survey Type	Floor	Analysis
	20 Dec 2022	Matthew Monro	Management Survey	External	Chrysotile (1)
	Building	Room	Item	Quantity	
	St Thomas More Primary School	External areas E01	Cement board Soffit	5m²	
	Sample No (S,SP,P,As)	Product Type	Surface Treatment	Condition	Accessibility
	As AB005146 (SP)	Asbestos Cement (1)	Surface Sealed (1)	Low Damage (1)	Usually inaccessible or unlikely to be disturbed
	Material Risk Score				
	4				
Recommended action	D - No Attention Required, Label				
Surveyor comments	Cement board used as soffit and upstand around windows of the reception classroom

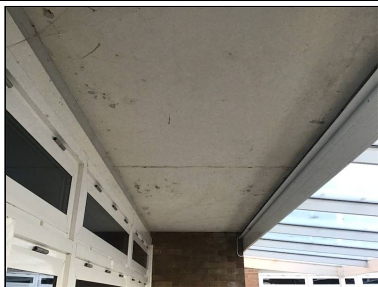
Survey Date:	Lead Surveyor	Survey Type	Floor	Analysis
	20 Dec 2022	Matthew Monro	Management Survey	External	Chrysotile (1)
	Building	Room	Item	Quantity	
	St Thomas More Primary School	External areas E01	Cement board Soffit	5m²	
	Sample No (S,SP,P,As)	Product Type	Surface Treatment	Condition	Accessibility
	As AB005146 (SP)	Asbestos Cement (1)	Surface Sealed (1)	Low Damage (1)	Usually inaccessible or unlikely to be disturbed
	Material Risk Score				
4					
Recommended action	D - No Attention Required, Label				
Surveyor comments	Cement board used as soffit and upstand around windows year 2 classroom

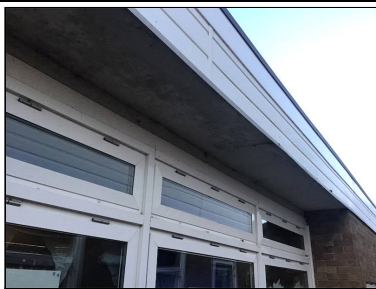
Survey Date:	Lead Surveyor	Survey Type	Floor	Analysis
	20 Dec 2022	Matthew Monro	Management Survey	External	Chrysotile (1)
	Building	Room	Item	Quantity	
	St Thomas More Primary School	External areas E01	Cement board Soffit	5lm	
	Sample No (S,SP,P,As)	Product Type	Surface Treatment	Condition	Accessibility
	As AB005146 (SP)	Asbestos Cement (1)	Surface Sealed (1)	Low Damage (1)	Usually inaccessible or unlikely to be disturbed
	Material Risk Score				
	4				
Recommended action	D - No Attention Required, Label				
Surveyor comments	Cement board used as soffit and upstand around windows of year 2 classroom

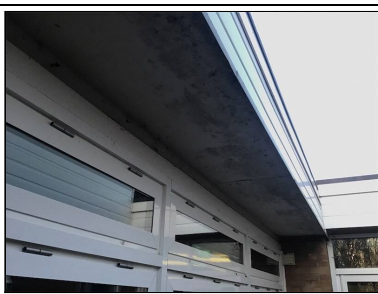
Survey Date:	Lead Surveyor	Survey Type	Floor	Analysis
	20 Dec 2022	Matthew Monro	Management Survey	External	Chrysotile (1)
	Building	Room	Item	Quantity	
	St Thomas More Primary School	External areas E01	Cement board Soffit	5lm	
	Sample No (S,SP,P,As)	Product Type	Surface Treatment	Condition	Accessibility
	As AB005146 (SP)	Asbestos Cement (1)	Surface Sealed (1)	Low Damage (1)	Usually inaccessible or unlikely to be disturbed
	Material Risk Score				
	4				
Recommended action	D - No Attention Required, Label				
Surveyor comments	Cement board used as soffit and upstand around windows year 3 classroom

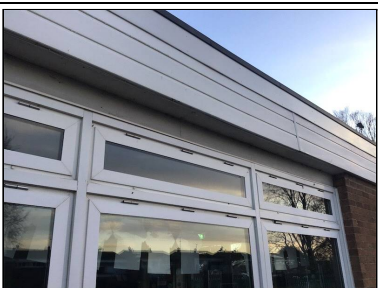
Survey Date:	Lead Surveyor	Survey Type	Floor	Analysis
	20 Dec 2022	Matthew Monro	Management Survey	External	Chrysotile (1)
	Building	Room	Item	Quantity	
	St Thomas More Primary School	External areas E01	Cement board Soffit	5lm	
	Sample No (S,SP,P,As)	Product Type	Surface Treatment	Condition	Accessibility
	As AB005146 (SP)	Asbestos Cement (1)	Surface Sealed (1)	Low Damage (1)	Usually inaccessible or unlikely to be disturbed
	Material Risk Score				
	4				
Recommended action	D - No Attention Required, Label				
Surveyor comments	Cement board used as soffit and upstand around windows of year 5 classroom

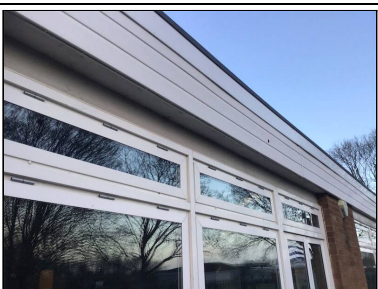
Survey Date:	Lead Surveyor	Survey Type	Floor	Analysis
	20 Dec 2022	Matthew Monro	Management Survey	External	Chrysotile (1)
	Building	Room	Item	Quantity	
	St Thomas More Primary School	External areas E01	Cement board Soffit	5lm	
	Sample No (S,SP,P,As)	Product Type	Surface Treatment	Condition	Accessibility
	As AB005146 (SP)	Asbestos Cement (1)	Surface Sealed (1)	Low Damage (1)	Usually inaccessible or unlikely to be disturbed
	Material Risk Score				
	4				
Recommended action	D - No Attention Required, Label				
Surveyor comments	Cement board used as soffit and upstand around windows of year 5 classroom

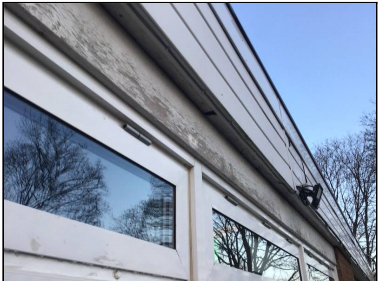
Survey Date:	Lead Surveyor	Survey Type	Floor	Analysis
	20 Dec 2022	Matthew Monro	Management Survey	External	Chrysotile (1)
	Building	Room	Item	Quantity	
	St Thomas More Primary School	External areas E01	Cement board Soffit	5lm	
	Sample No (S,SP,P,As)	Product Type	Surface Treatment	Condition	Accessibility
	As AB005146 (SP)	Asbestos Cement (1)	Surface Sealed (1)	Low Damage (1)	Usually inaccessible or unlikely to be disturbed
	Material Risk Score				
Recommended action		D - No Attention Required, Label			
Surveyor comments		Cement board used as soffit and upstand around windows of equipment store

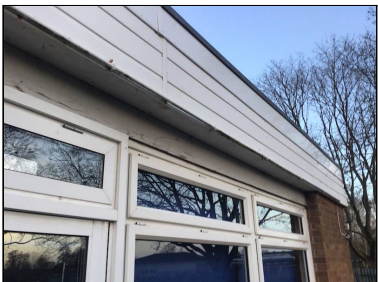
Survey Date:	Lead Surveyor	Survey Type	Floor	Analysis
	20 Dec 2022	Matthew Monro	Management Survey	External	Chrysotile (1)
	Building	Room	Item	Quantity	
	St Thomas More Primary School	External areas E01	Cement board Soffit	5lm	
	Sample No (S,SP,P,As)	Product Type	Surface Treatment	Condition	Accessibility
	As AB005146 (SP)	Asbestos Cement (1)	Surface Sealed (1)	Low Damage (1)	Usually inaccessible or unlikely to be disturbed
	Material Risk Score				
Recommended action		D - No Attention Required, Label			
Surveyor comments		Cement board used as soffit and upstand around windows of year 6 classroom

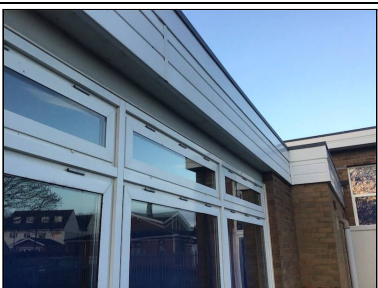
Survey Date:	Lead Surveyor	Survey Type	Floor	Analysis
	20 Dec 2022	Matthew Monro	Management Survey	External	Chrysotile (1)
	Building	Room	Item	Quantity	
	St Thomas More Primary School	External areas E01	Cement board Soffit	5lm	
	Sample No (S,SP,P,As)	Product Type	Surface Treatment	Condition	Accessibility
	As AB005146 (SP)	Asbestos Cement (1)	Surface Sealed (1)	Low Damage (1)	Usually inaccessible or unlikely to be disturbed
	Material Risk Score				
	4				
Recommended action	D - No Attention Required, Label				
Surveyor comments	Cement board used as soffit and upstand around windows of year 6 classroom

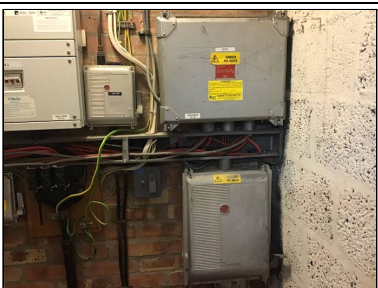
Survey Date:	Lead Surveyor	Survey Type	Floor	Analysis
	20 Dec 2022	Matthew Monro	Management Survey	Ground Floor	Crocidolite (or unknown) (3)
	Building	Room	Item	Quantity	
	St Thomas More Primary School	Electrical cupboard G10	Presumed flash guards Fuse boxes	Unknown	
	Sample No (S,SP,P,As)	Product Type	Surface Treatment	Condition	Accessibility
	Visual (P)	Asbestos Textiles/Paper (2)	Unsealed (2)	Good Condition (0)	Usually inaccessible or unlikely to be disturbed
	Material Risk Score				
	7				
Recommended action	D - No Attention Required, Label				
Surveyor comments	Presumed asbestos in old fuse boxes. Unable to sample as fuse are live.

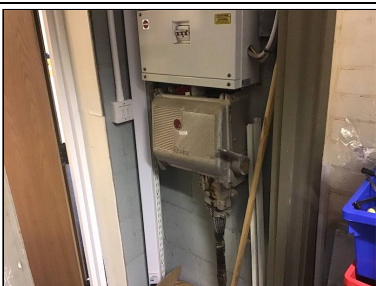
Survey Date:	Lead Surveyor	Survey Type	Floor	Analysis
	20 Dec 2022	Matthew Monro	Management Survey	Ground Floor	Crocidolite (or unknown) (3)
	Building	Room	Item	Quantity	
	St Thomas More Primary School	Caretakers store G34	Presumed flash guards Fuse box	Unknown	
	Sample No (S,SP,P,As)	Product Type	Surface Treatment	Condition	Accessibility
	Visual (P)	Asbestos Textiles/Paper (2)	Unsealed (2)	Good Condition (0)	Usually inaccessible or unlikely to be disturbed
	Material Risk Score				
	7				
Recommended action	D - No Attention Required, Label				
Surveyor comments	Presumed flash guards to old fue box. Unable to sample as box is live.
