Management Survey

St. Thomas More Rc School
Oxford Road
Kidlington
Oxfordshire
OX5 1EA

Amity

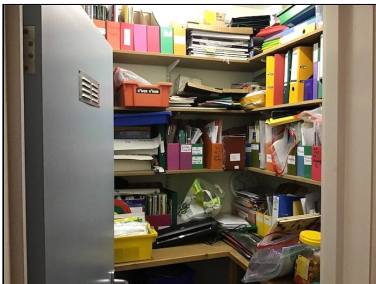
Survey Date:	Lead Surveyor	Survey Type	Floor	Analysis
	20 Dec 2022	Matthew Monro	Management Survey	Ground Floor	N/A
	Building	Room	Item	Quantity	
	St Thomas More Primary School	Year 4 classroom store G32	No suspect materials found	N/A	
	Sample No (S,SP,P,As)	Product Type	Surface Treatment	Condition	Accessibility
	Visual	N/A	N/A	N/A	N/A
	Material Risk Score				
Recommended action		No further action required			
Surveyor comments		N/A

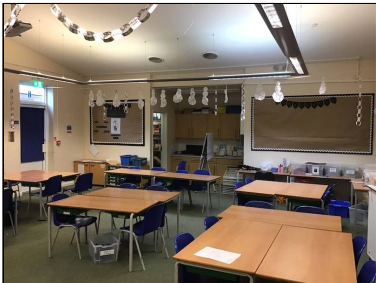
Survey Date:	Lead Surveyor	Survey Type	Floor	Analysis
	20 Dec 2022	Matthew Monro	Management Survey	Ground Floor	N/A
	Building	Room	Item	Quantity	
	St Thomas More Primary School	Year 4 classroom G33	No suspect materials found	N/A	
	Sample No (S,SP,P,As)	Product Type	Surface Treatment	Condition	Accessibility
	Visual	N/A	N/A	N/A	N/A
	Material Risk Score				
Recommended action		No further action required			
Surveyor comments		N/A

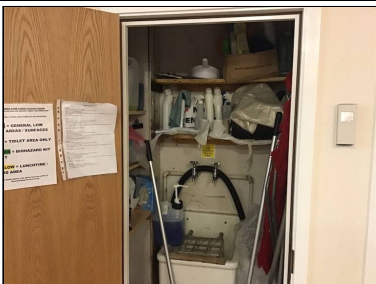
Survey Date:	Lead Surveyor	Survey Type	Floor	Analysis
	20 Dec 2022	Matthew Monro	Management Survey	Ground Floor	N/A
	Building	Room	Item	Quantity	
	St Thomas More Primary School	Cleaners store G35	No suspect materials found	N/A	
	Sample No (S,SP,P,As)	Product Type	Surface Treatment	Condition	Accessibility
	Visual	N/A	N/A	N/A	N/A
	Material Risk Score				
N/A					
Recommended action	No further action required				
Surveyor comments	N/A

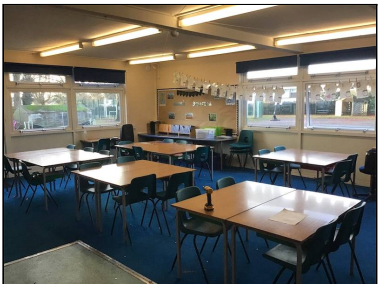
Survey Date:	Lead Surveyor	Survey Type	Floor	Analysis
	20 Dec 2022	Matthew Monro	Management Survey	Ground Floor	N/A
	Building	Room	Item	Quantity	
	St Thomas More Primary School	Year 5 G36	No suspect materials found	N/A	
	Sample No (S,SP,P,As)	Product Type	Surface Treatment	Condition	Accessibility
	Visual	N/A	N/A	N/A	N/A
	Material Risk Score				
Recommended action		No further action required			
Surveyor comments		N/A

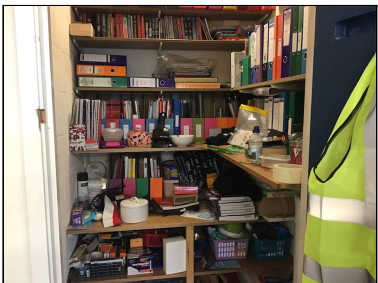
Survey Date:	Lead Surveyor	Survey Type	Floor	Analysis
	20 Dec 2022	Matthew Monro	Management Survey	Ground Floor	N/A
	Building	Room	Item	Quantity	
	St Thomas More Primary School	Year 5 store 1 G37	No suspect materials found	N/A	
	Sample No (S,SP,P,As)	Product Type	Surface Treatment	Condition	Accessibility
	Visual	N/A	N/A	N/A	N/A
	Material Risk Score				
Recommended action		No further action required			
Surveyor comments		N/A

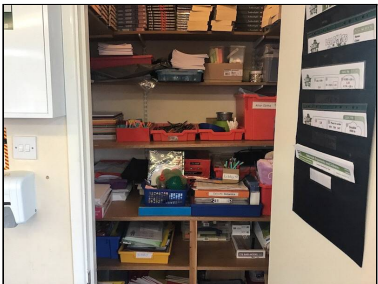
Survey Date:	Lead Surveyor	Survey Type	Floor	Analysis
	20 Dec 2022	Matthew Monro	Management Survey	Ground Floor	N/A
	Building	Room	Item	Quantity	
	St Thomas More Primary School	Year 5 store 2 G38	No suspect materials found	N/A	
	Sample No (S,SP,P,As)	Product Type	Surface Treatment	Condition	Accessibility
	Visual	N/A	N/A	N/A	N/A
	Material Risk Score				
Recommended action		No further action required			
Surveyor comments		N/A

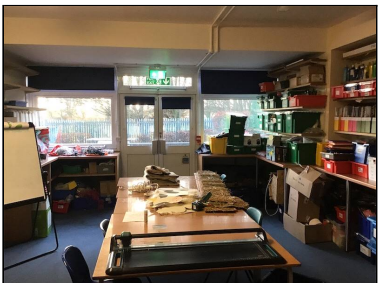
Survey Date:	Lead Surveyor	Survey Type	Floor	Analysis
	20 Dec 2022	Matthew Monro	Management Survey	Ground Floor	N/A
	Building	Room	Item	Quantity	
	St Thomas More Primary School	Equipment store G39	No suspect materials found	N/A	
	Sample No (S,SP,P,As)	Product Type	Surface Treatment	Condition	Accessibility
	Visual	N/A	N/A	N/A	N/A
	Material Risk Score				
Recommended action		No further action required			
Surveyor comments		N/A

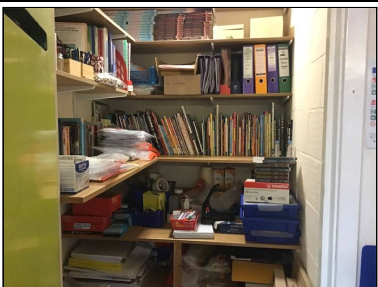
Survey Date:	Lead Surveyor	Survey Type	Floor	Analysis
	20 Dec 2022	Matthew Monro	Management Survey	Ground Floor	N/A
	Building	Room	Item	Quantity	
	St Thomas More Primary School	Year 6 store 1 G40	No suspect materials found	N/A	
	Sample No (S,SP,P,As)	Product Type	Surface Treatment	Condition	Accessibility
	Visual	N/A	N/A	N/A	N/A
	Material Risk Score				
Recommended action		No further action required			
Surveyor comments		N/A

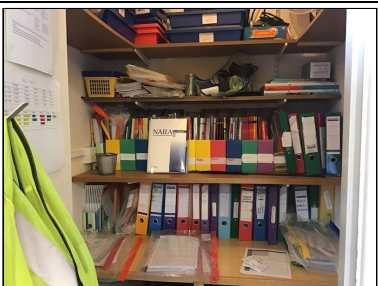
Survey Date:	Lead Surveyor	Survey Type	Floor	Analysis
	20 Dec 2022	Matthew Monro	Management Survey	Ground Floor	N/A
	Building	Room	Item	Quantity	
	St Thomas More Primary School	Year 6 store 2 G41	No suspect materials found	N/A	
	Sample No (S,SP,P,As)	Product Type	Surface Treatment	Condition	Accessibility
	Visual	N/A	N/A	N/A	N/A
	Material Risk Score				
Recommended action		No further action required			
Surveyor comments		N/A

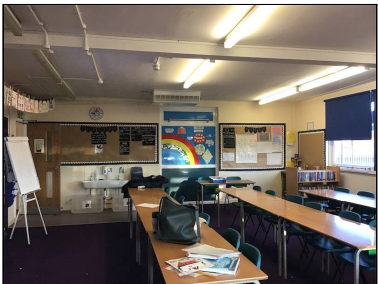
Survey Date:	Lead Surveyor	Survey Type	Floor	Analysis
	20 Dec 2022	Matthew Monro	Management Survey	Ground Floor	N/A
	Building	Room	Item	Quantity	
	St Thomas More Primary School	Year 6 classroom G42	No suspect materials found	N/A	
	Sample No (S,SP,P,As)	Product Type	Surface Treatment	Condition	Accessibility
	Visual	N/A	N/A	N/A	N/A
	Material Risk Score				
Recommended action		No further action required			
Surveyor comments		N/A

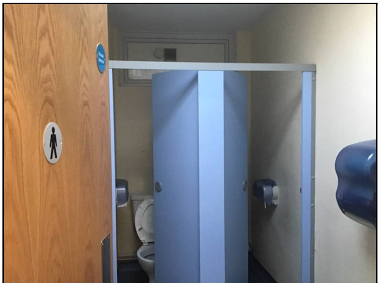
Survey Date:	Lead Surveyor	Survey Type	Floor	Analysis
	20 Dec 2022	Matthew Monro	Management Survey	Ground Floor	N/A
	Building	Room	Item	Quantity	
	St Thomas More Primary School	Boys toilet G43	No suspect materials found	N/A	
	Sample No (S,SP,P,As)	Product Type	Surface Treatment	Condition	Accessibility
	Visual	N/A	N/A	N/A	N/A
	Material Risk Score				
Recommended action		No further action required			
Surveyor comments		N/A

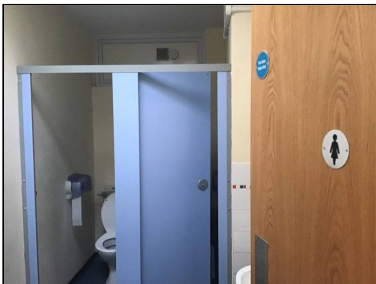
Survey Date:	Lead Surveyor	Survey Type	Floor	Analysis
	20 Dec 2022	Matthew Monro	Management Survey	Ground Floor	N/A
	Building	Room	Item	Quantity	
	St Thomas More Primary School	Girls toilet G44	No suspect materials found	N/A	
	Sample No (S,SP,P,As)	Product Type	Surface Treatment	Condition	Accessibility
	Visual	N/A	N/A	N/A	N/A
	Material Risk Score				
Recommended action		No further action required			
Surveyor comments		N/A

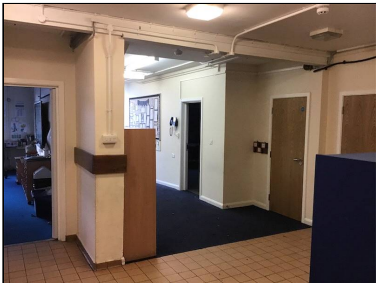
Survey Date:	Lead Surveyor	Survey Type	Floor	Analysis
	20 Dec 2022	Matthew Monro	Management Survey	Ground Floor	N/A
	Building	Room	Item	Quantity	
	St Thomas More Primary School	Circulation 4 G45	No suspect materials found	N/A	
	Sample No (S,SP,P,As)	Product Type	Surface Treatment	Condition	Accessibility
	Visual	N/A	N/A	N/A	N/A
	Material Risk Score				
Recommended action		No further action required			
Surveyor comments		N/A

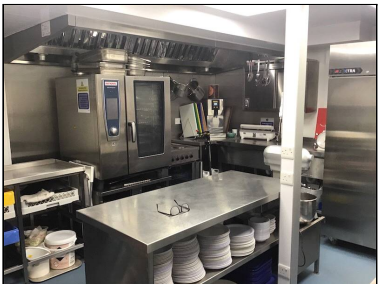
Survey Date:	Lead Surveyor	Survey Type	Floor	Analysis
	20 Dec 2022	Matthew Monro	Management Survey	Ground Floor	N/A
	Building	Room	Item	Quantity	
	St Thomas More Primary School	Kitchen G46	No suspect materials found	N/A	
	Sample No (S,SP,P,As)	Product Type	Surface Treatment	Condition	Accessibility
	Visual	N/A	N/A	N/A	N/A
	Material Risk Score				
Recommended action		No further action required			
Surveyor comments		N/A

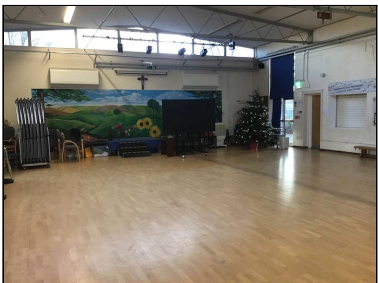
Survey Date:	Lead Surveyor	Survey Type	Floor	Analysis
	20 Dec 2022	Matthew Monro	Management Survey	Ground Floor	N/A
	Building	Room	Item	Quantity	
	St Thomas More Primary School	Hall G47	No suspect materials found	N/A	
	Sample No (S,SP,P,As)	Product Type	Surface Treatment	Condition	Accessibility
	Visual	N/A	N/A	N/A	N/A
	Material Risk Score				
Recommended action		No further action required			
Surveyor comments		N/A

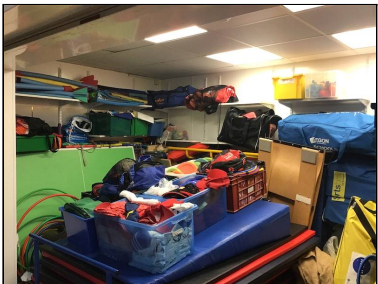
Survey Date:	Lead Surveyor	Survey Type	Floor	Analysis
	20 Dec 2022	Matthew Monro	Management Survey	Ground Floor	N/A
	Building	Room	Item	Quantity	
	St Thomas More Primary School	Hall store G48	No suspect materials found	N/A	
	Sample No (S,SP,P,As)	Product Type	Surface Treatment	Condition	Accessibility
	Visual	N/A	N/A	N/A	N/A
	Material Risk Score				
Recommended action		No further action required			
Surveyor comments		N/A

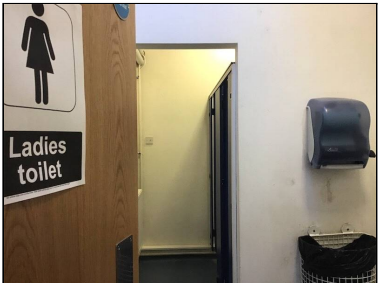
Survey Date:	Lead Surveyor	Survey Type	Floor	Analysis
	20 Dec 2022	Matthew Monro	Management Survey	Ground Floor	N/A
	Building	Room	Item	Quantity	
	St Thomas More Primary School	Ladies toilet G49	No suspect materials found	N/A	
	Sample No (S,SP,P,As)	Product Type	Surface Treatment	Condition	Accessibility
	Visual	N/A	N/A	N/A	N/A
	Material Risk Score				
Recommended action		No further action required			
Surveyor comments		N/A

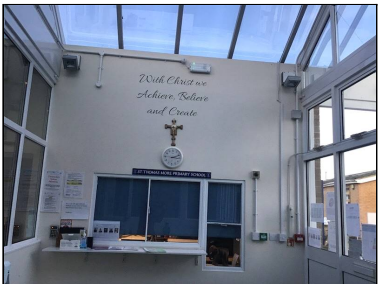
Survey Date:	Lead Surveyor	Survey Type	Floor	Analysis
	20 Dec 2022	Matthew Monro	Management Survey	Ground Floor	N/A
	Building	Room	Item	Quantity	
	St Thomas More Primary School	Reception lobby G50	No suspect materials found	N/A	
	Sample No (S,SP,P,As)	Product Type	Surface Treatment	Condition	Accessibility
	Visual	N/A	N/A	N/A	N/A
	Material Risk Score				
Recommended action		No further action required			
Surveyor comments		N/A

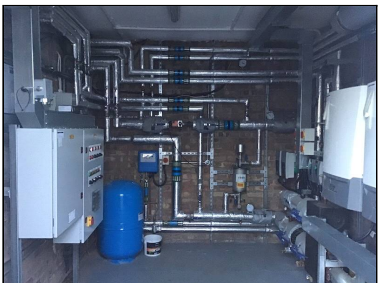
Survey Date:	Lead Surveyor	Survey Type	Floor	Analysis
	20 Dec 2022	Matthew Monro	Management Survey	Ground Floor	N/A
	Building	Room	Item	Quantity	
	St Thomas More Primary School	Boiler room G51	No suspect materials found	N/A	
	Sample No (S,SP,P,As)	Product Type	Surface Treatment	Condition	Accessibility
	Visual	N/A	N/A	N/A	N/A
	Material Risk Score				
Recommended action		No further action required			
Surveyor comments		N/A
